737 GRAPHITE COMPOSITE FLIGHT SPOILER FLIGHT SERVICE EVALUATION

FIRST ANNUAL REPORT
JULY 1973 THROUGH MARCH 1975

Prepared under contract NAS1-11668 by
BOEING COMMERCIAL AIRPLANE COMPANY
P.O. Box 3707
Seattle, Washington 98124

May 1975

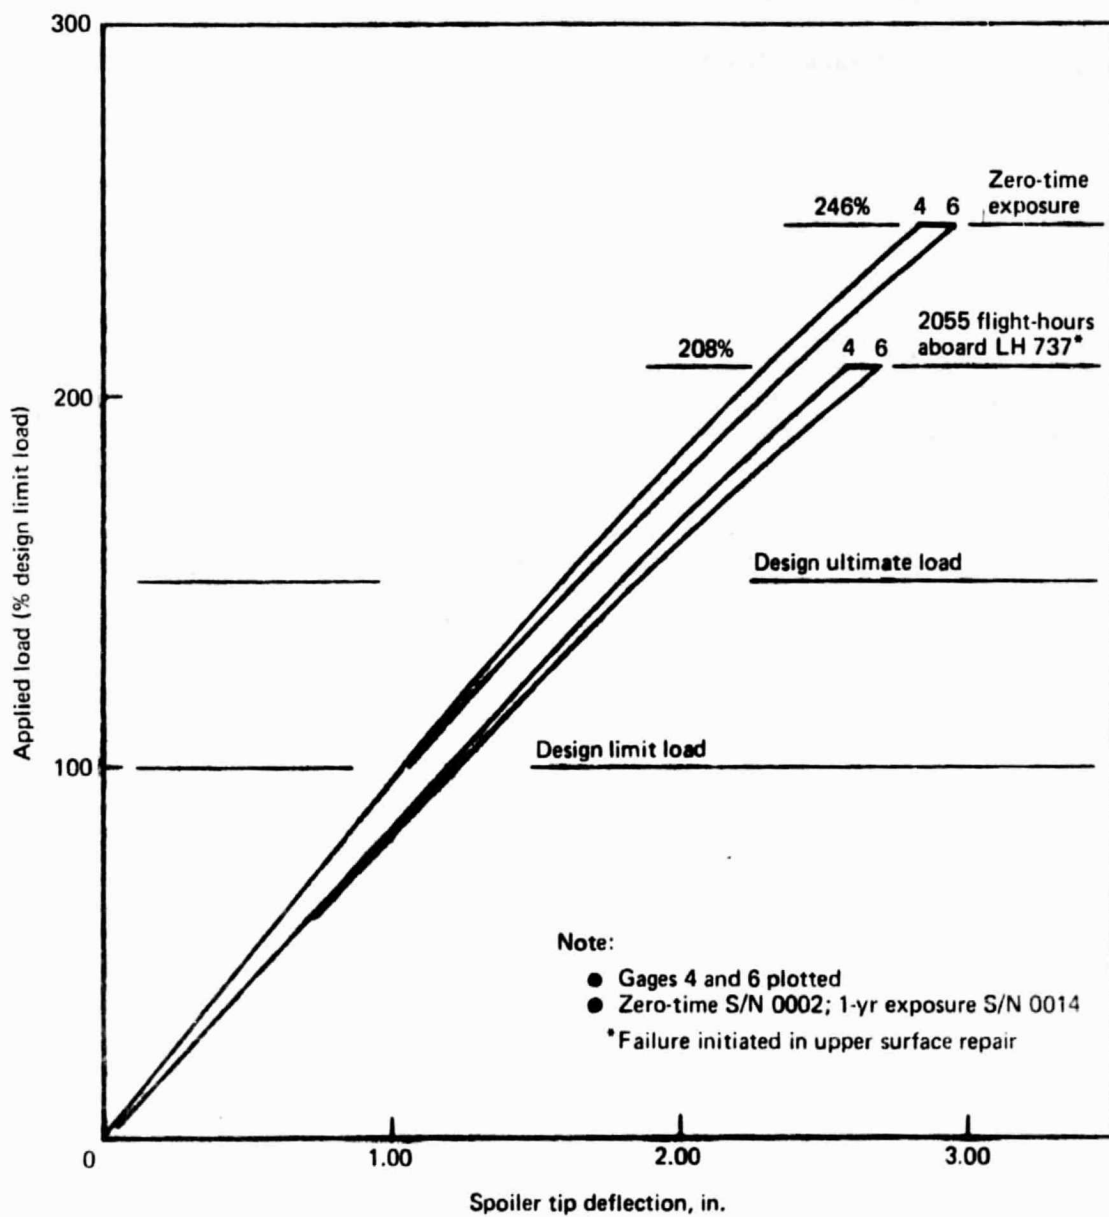
Figure 8.—Load-Deflection Curves—Zero-Time and 1-Year Exposure
(Union Carbide T300/2544 Material System)

The static test setup from the original certification testing was used to conduct these tests. All three tests were conducted on the same working day. Test results are plotted in figures 8, 9, and 10, with the corresponding plots of the certification testing included in each figure. Failure load levels of the current tests are considered satisfactory since they equal or exceed the values achieved by the production aluminum spoiler (ref. 1, Third Quarterly Report, April 1973). Photos of the failed test spoilers are shown in figures 11, 12, and 13.

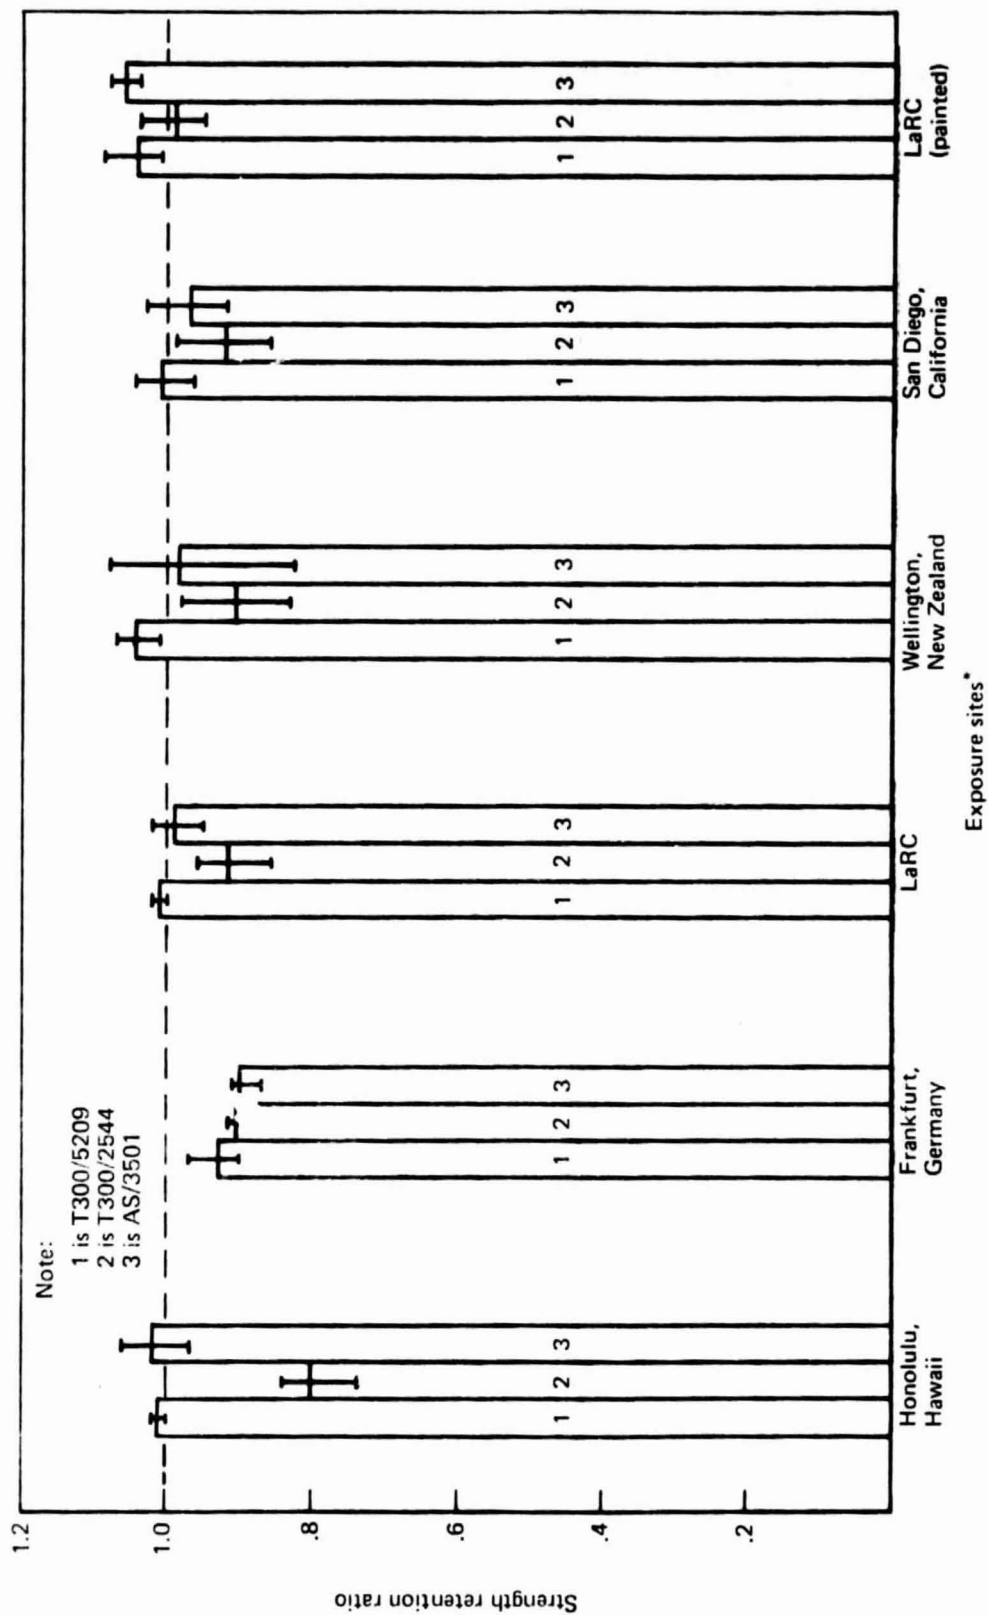
Figure 19.—Interlaminar Shear Strengths of Graphite-Epoxy Composites After 1-Year Outdoor Ground Exposure

Tables 6, 7, and 8 give results of tests on shear, flexure, and compression specimens of the three graphite-epoxy material systems following 1 year of environmental exposure at five of the six sites. Comparisons with the test results on unexposed baseline specimens are made in the bar graphs of figures 19, 20, and 21. These three material systems show generally less than 10% change in mechanical properties. Moisture pickup by these materials has been generally less than 1% based on changes in specimen weight. Although the change in material properties is about the same order of magnitude as the change in static strength and stiffness of the spoilers, neither is large enough to be significant by itself. The overall effects of the first year of the outdoor exposure program are summarized in table 9.
